**Remedial Action
Construction Summary Report**

**Combined Sheet Pile and Soil-Bentonite
Barrier Wall**

**McCormick & Baxter
Creosoting Company
Portland, Oregon**

April 2004

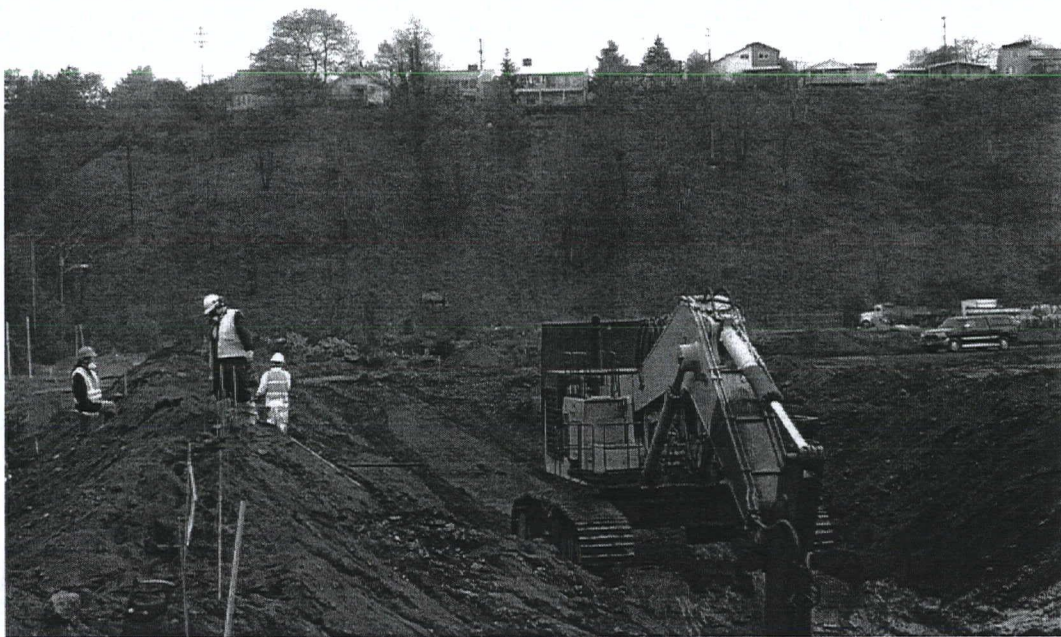
For safety reasons, monitoring was conducted approximately 3 to 9 m (10 to 30 ft) away from the trench, and field glasses were used to examine dirt as it was being dumped from the bucket (Figure 2). If possible artifacts or other archaeological deposits were observed, the archaeological monitor was to request that the excavated material be deposited where it could be safely examined. Mr. Baker completed daily monitoring logs designed specifically for the McCormick & Baxter project that summarized the results of each day's activities.

Figure 2. View to the northwest of the southwestern end of the slurry wall trench in progress.

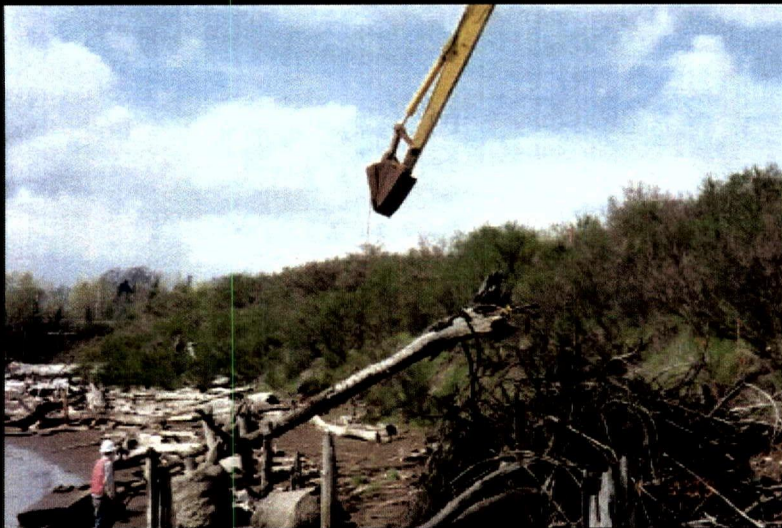
Photo 1 Log displacement to allow room for silt fence installation.
Direction: Northwest

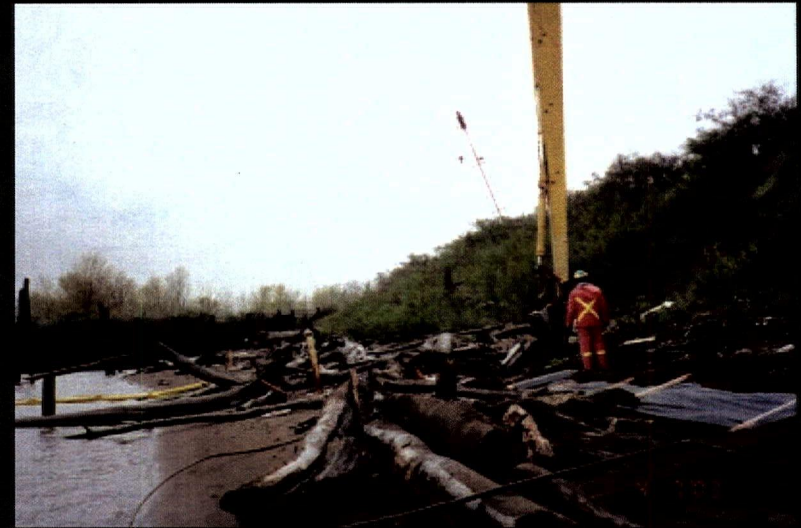
Photo 2 Pushing woody debris riverward to allow for silt fence installation and working platform construction.
Direction: Northwest

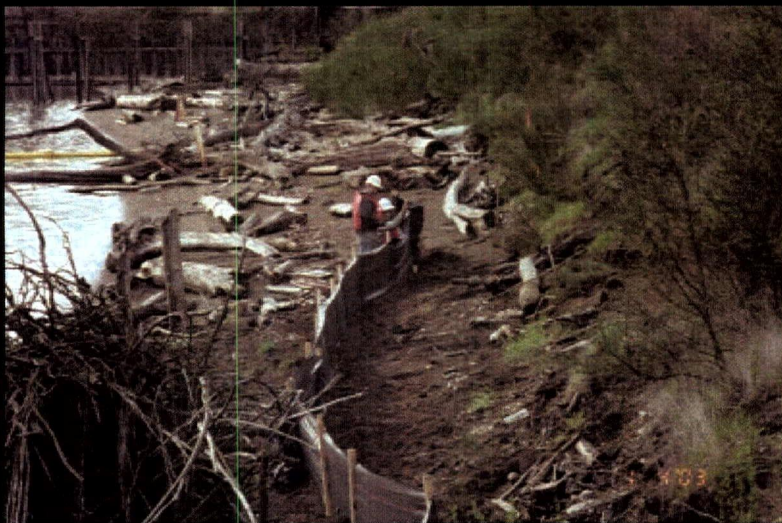
Photo 3 Installation of silt fencing (south of bulkhead).
Direction: Northwest

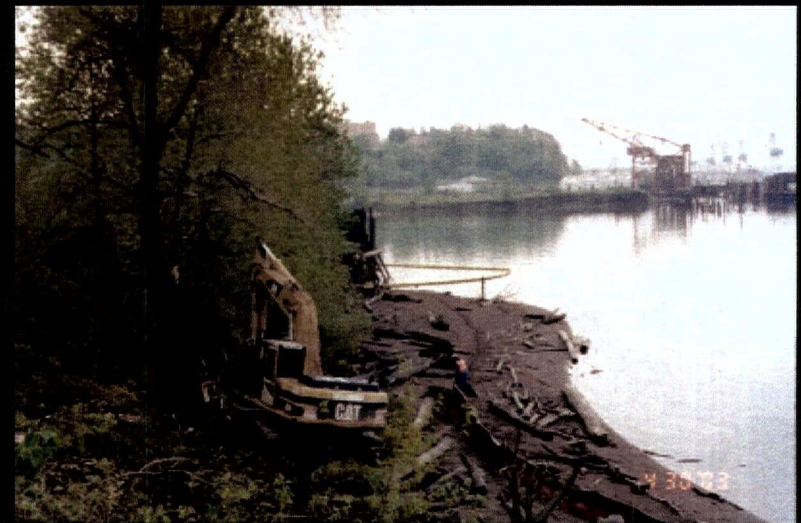
Photo 4 Clearing and grubbing on the beach north of the bulkhead while installation of silt fence continues towards the south.
Direction: Southeast

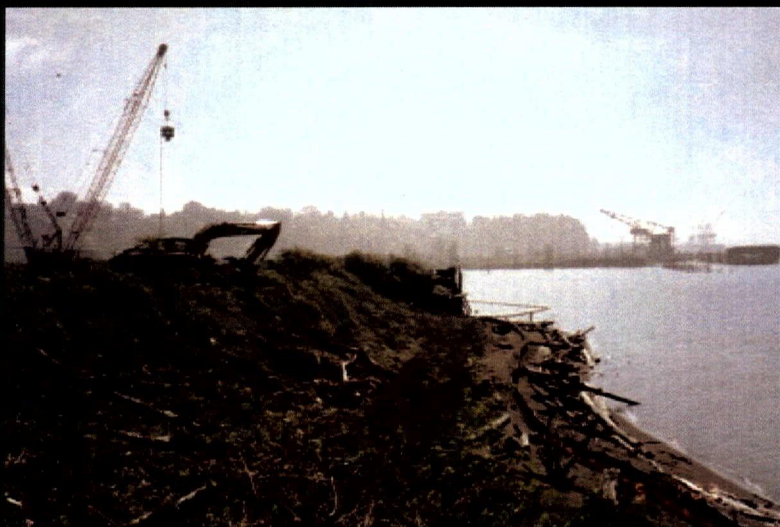
Photo 5 North beach with silt fence completely installed and approximately half the required clearing completed.
Direction: Southeast

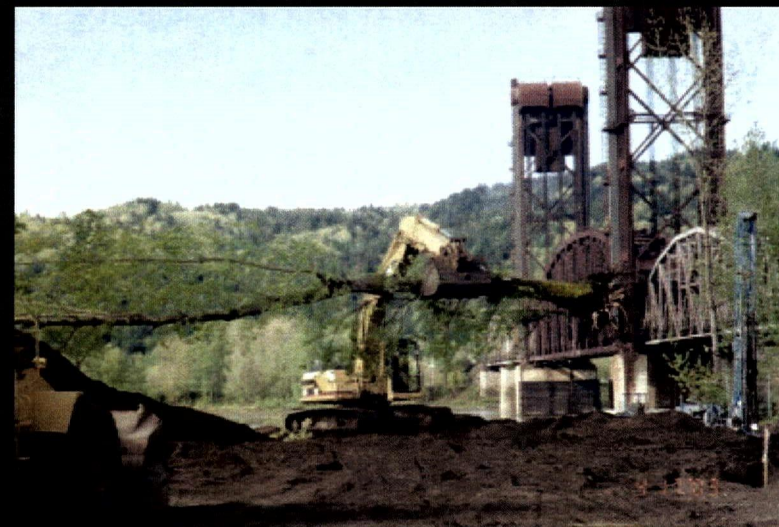
Photo 6 Clearing (tree removal) at NW end of site.
Direction: Northwest

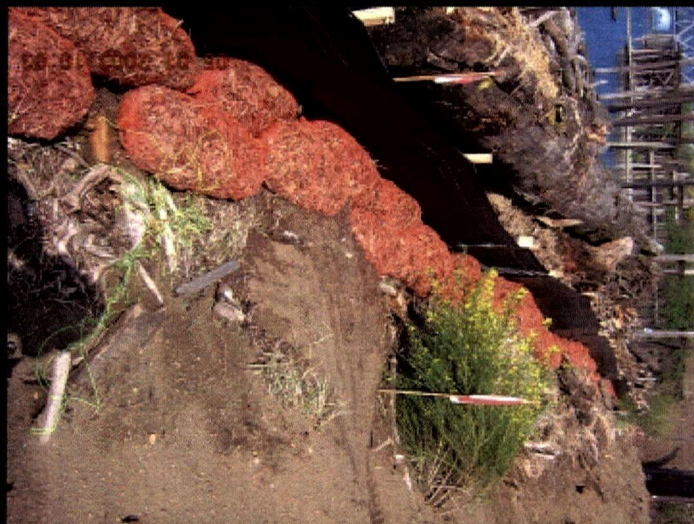
Photo 7 Visible erosion being stopped by bio-bags and silt fence.
Direction: South

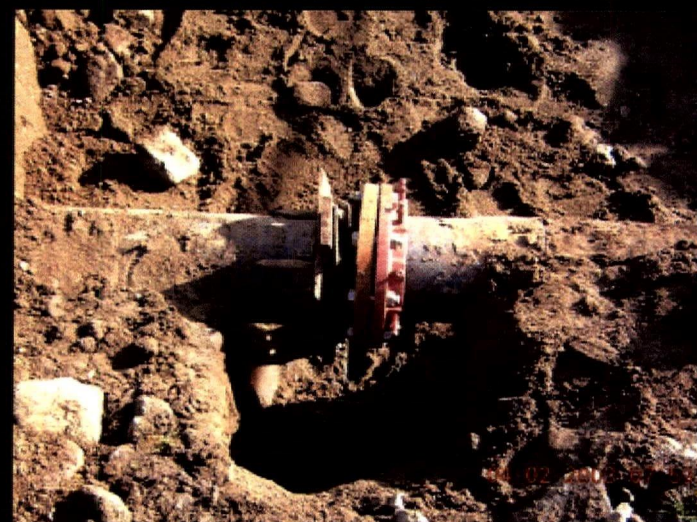
Photo 12 8" water line (near STA 38+00/1+00) cut and blind flange installed.
Direction: Down

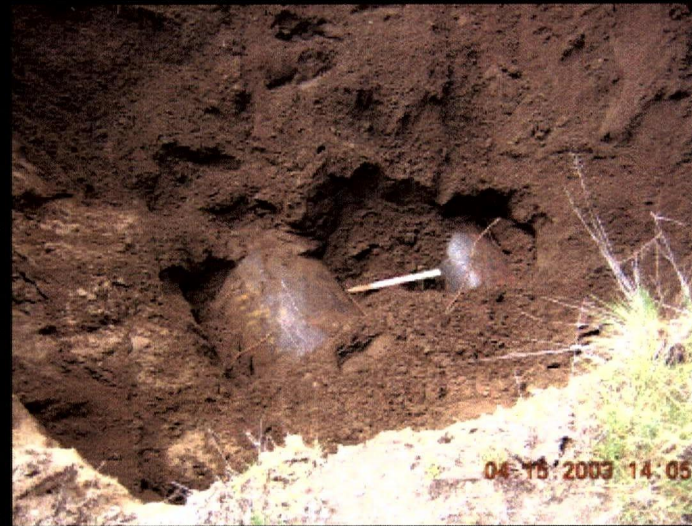
Photo 14 Stake showing separation of the 20 and 30-inch pressurized sewer lines.
Direction: South

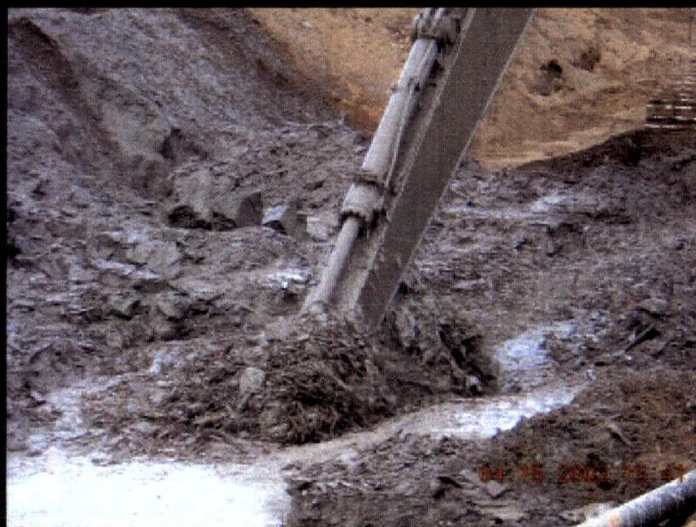
Photo 21 Excavating within wood chip area near
STA 37+50.
Direction: Down

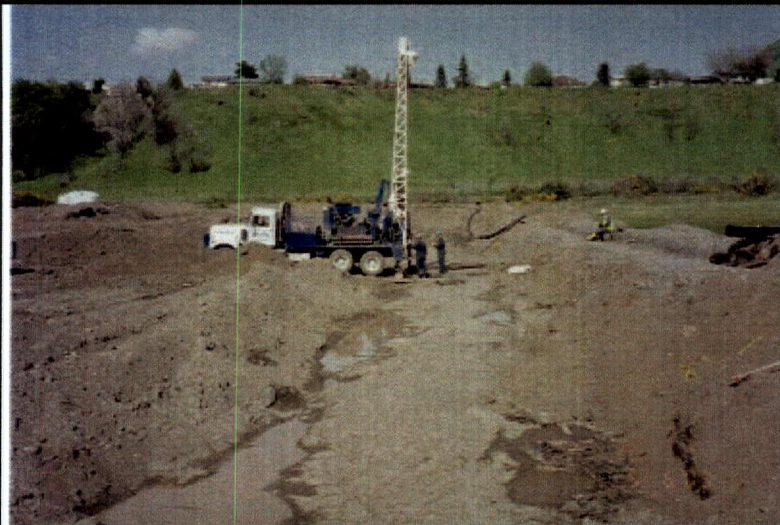
Photo 33 Drilling for S-B wall confirmation samples (STA 38+68).
Direction: Northeast

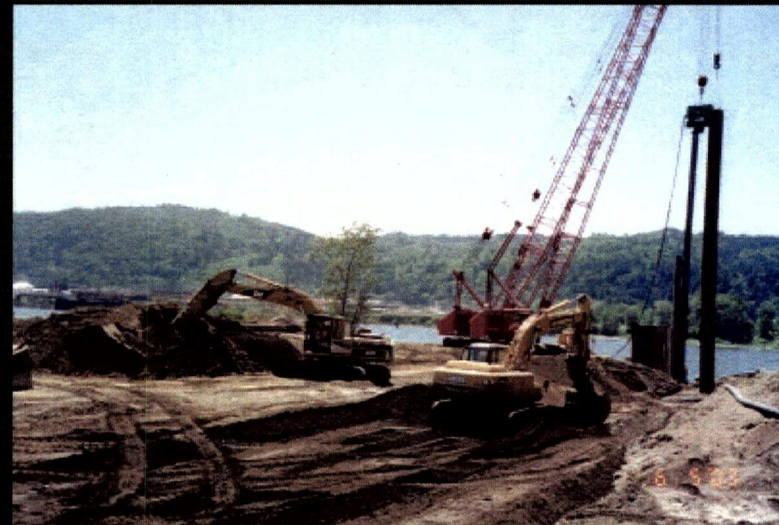
Photo 34 Constructing S-B wall protective cap near STA 17+00.
Direction: Southwest

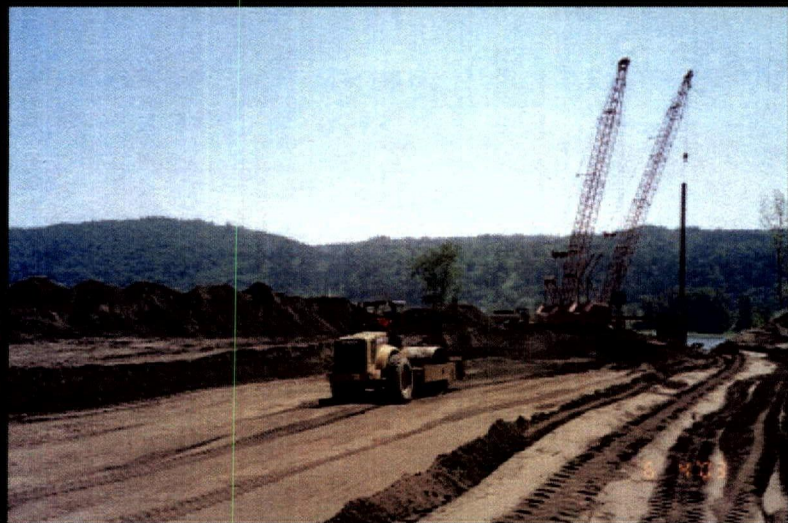
Photo 35 Roller compaction of the protective cap near STA 18+50.
Direction: Southwest

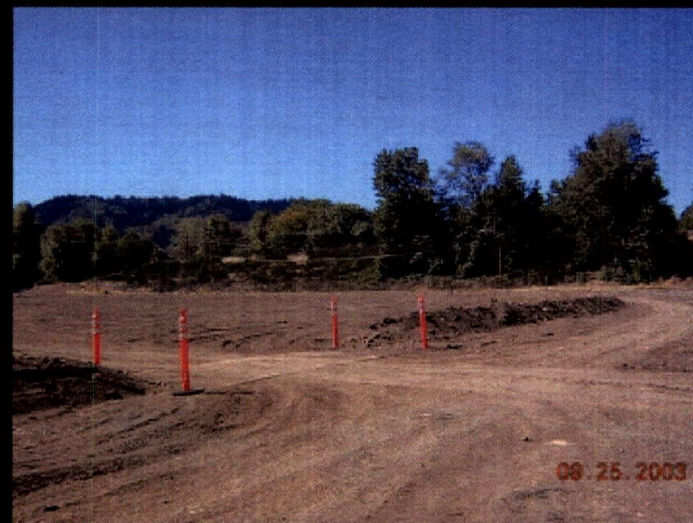
Photo 36 Permanent road crossing over S-B wall near STA 24+50.
Direction: Northwest

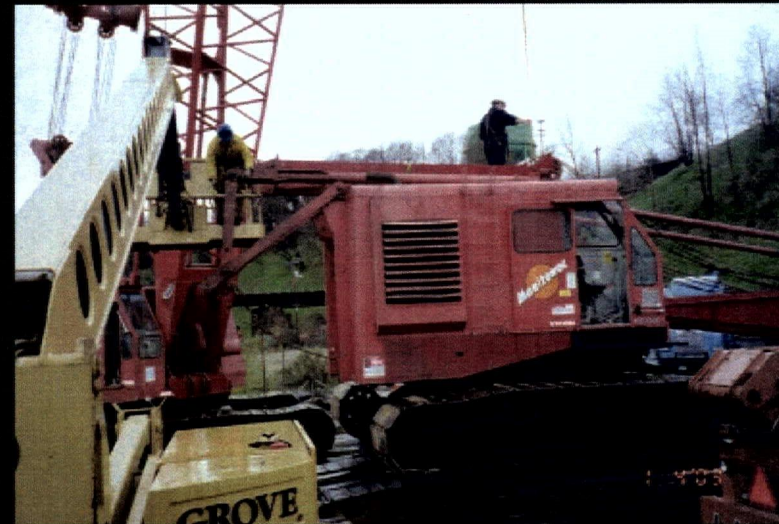
Photo 38 Assembling the 3900 Viccon Crane.
Direction: North

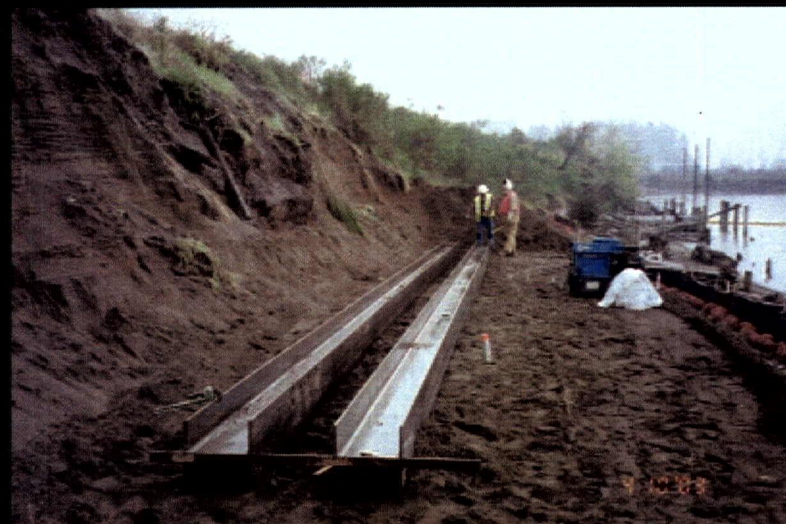
Photo 39 Positioning I-beam template/guide for sheet pile.
Direction: Southeast

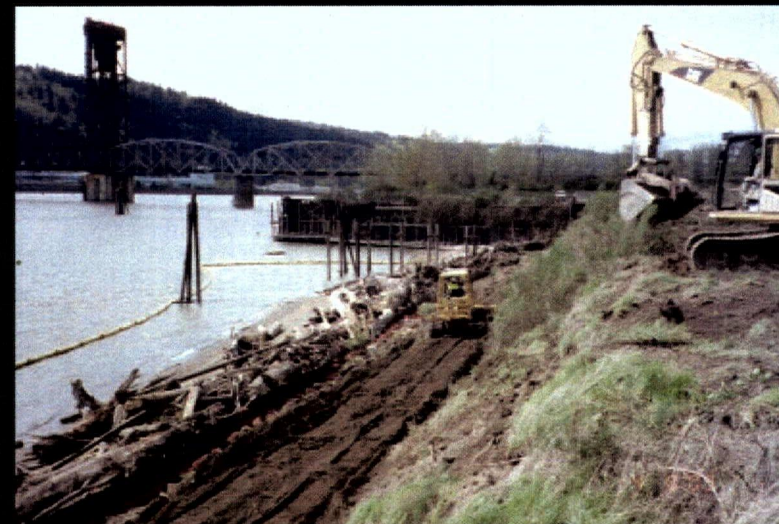
Photo 40 Constructing sheet pile working platform (south of bulkhead).
Direction: Northwest

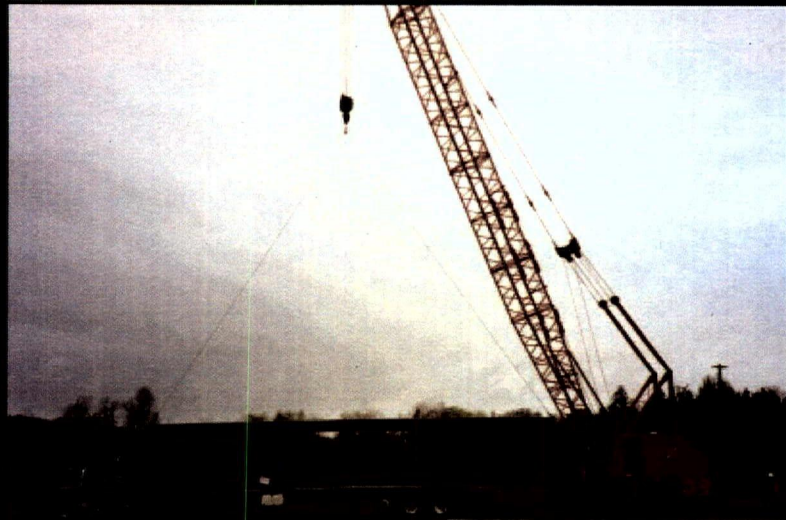
Photo 41 Unloading sheet pile from truck.
Direction: Northwest

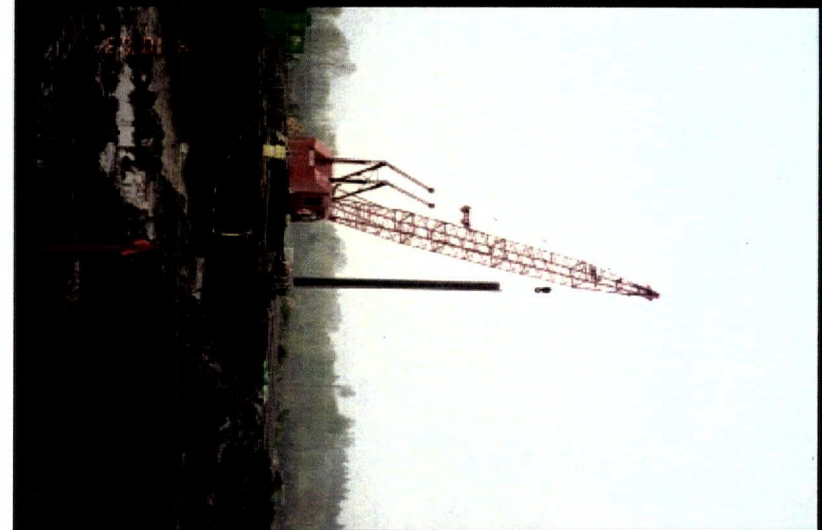
Photo 42 Crane with sheet pile being moved into position.
Direction: Northwest

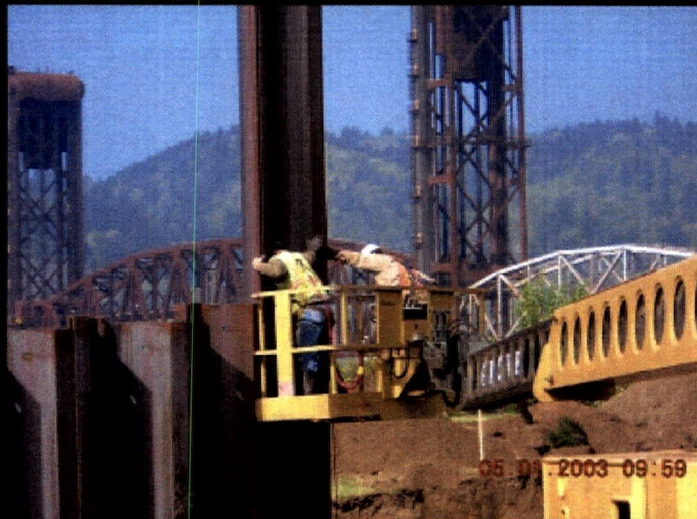
Photo 43 Sheet pile crew in bucket lift aligning 80' sheet.
Direction: West

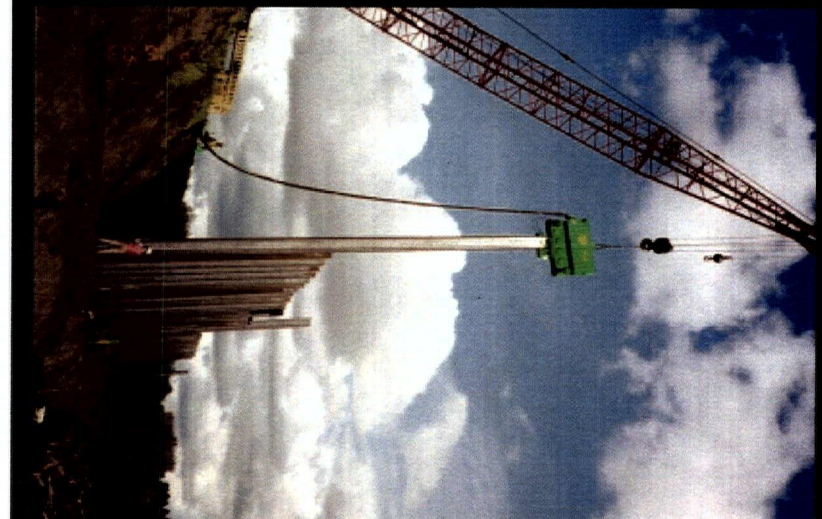
Photo 44 Sheet pile driving operation at approximately STA 4+00.
Direction: Southeast

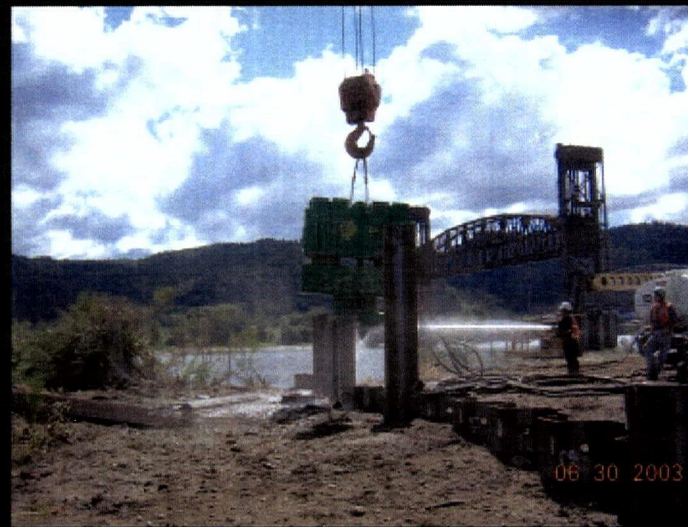
Photo 46 Refusal sheet being cooled and lubricated using water.
Direction: West

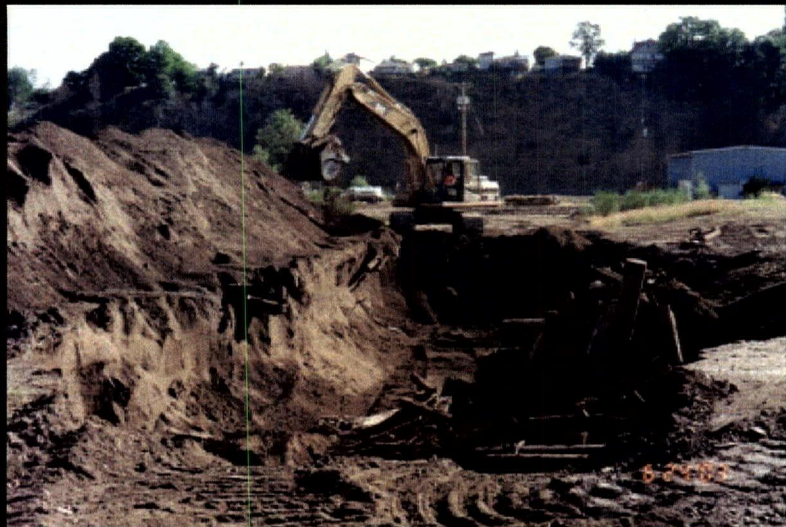
Photo 49 Miscellaneous debris disposal cell
Direction: Northeast

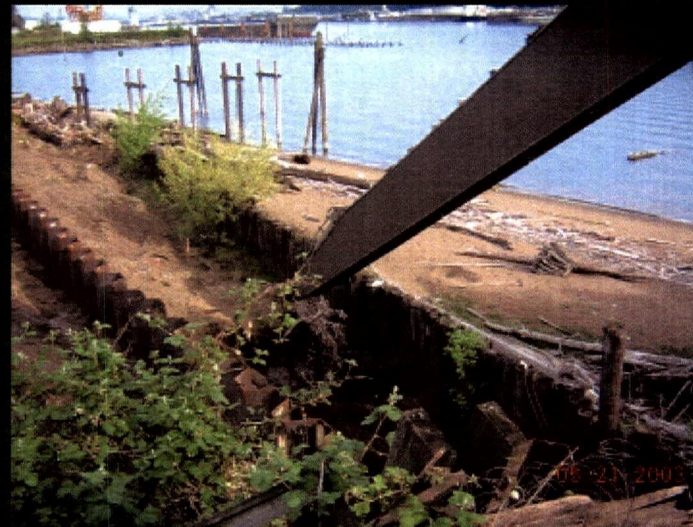
Photo 50 Potholing to assess the amount of
contamination in the interceptor trench.
Direction: South

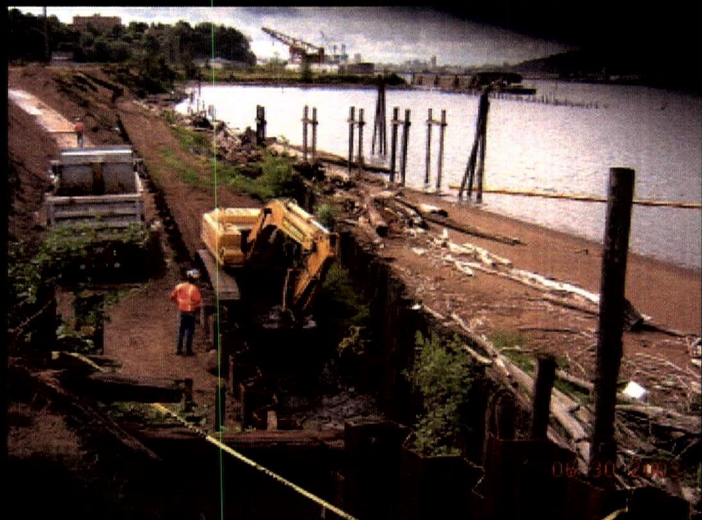
Photo 51 Excavating interceptor trench to further
capture source area. Spoils are being hauled
and placed within the wall.
Direction: South

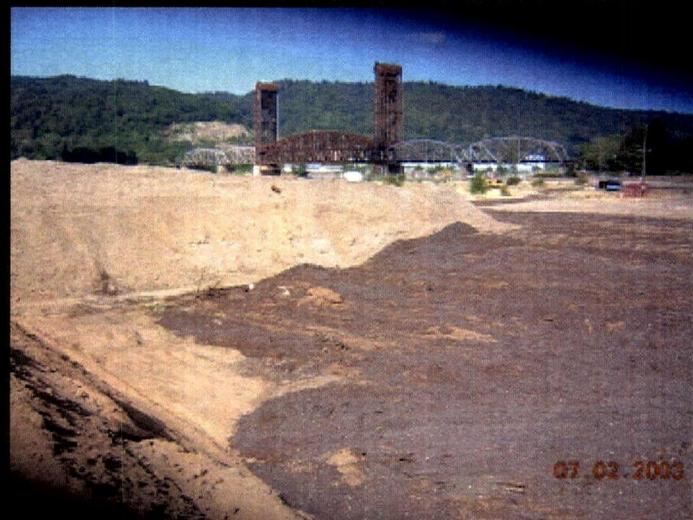
Photo 52 Interceptor trench spoils disposal cell within
the barrier wall.
Direction: Northwest

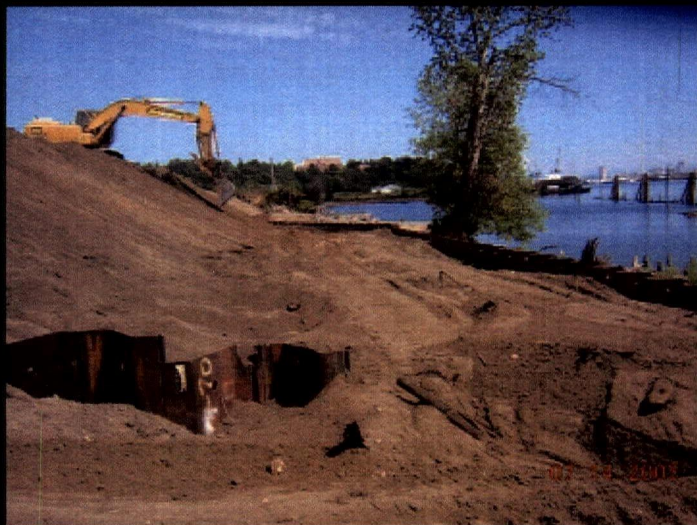
Photo 53 Bluff north of bulkhead getting finish graded in preparation for erosion control mat installation.
Direction: South

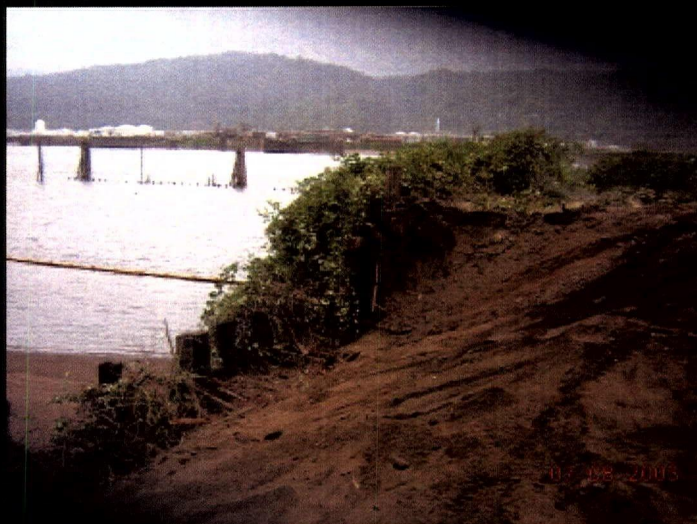
Photo 55 Bulkhead stabilized by grading the slope back and removal of timber structure.
Direction: West

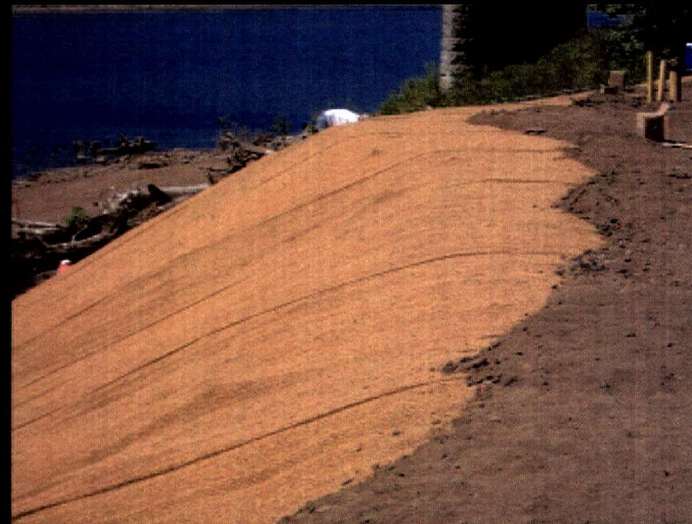
Photo 56 Jute mat erosion control placed and being stapled on the north end near tie in.
Direction: Northwest
